Property Condition Report

Case #: 105-207928
Address: 800 WILD AZALEA TRAIL
City: WALESKA
State/Zip: GA 30183
Inspection Date: 12/26/08
Inspection Type: Property Condition Report (PCR)
Prepared by: DEANCO Management Services, Inc.

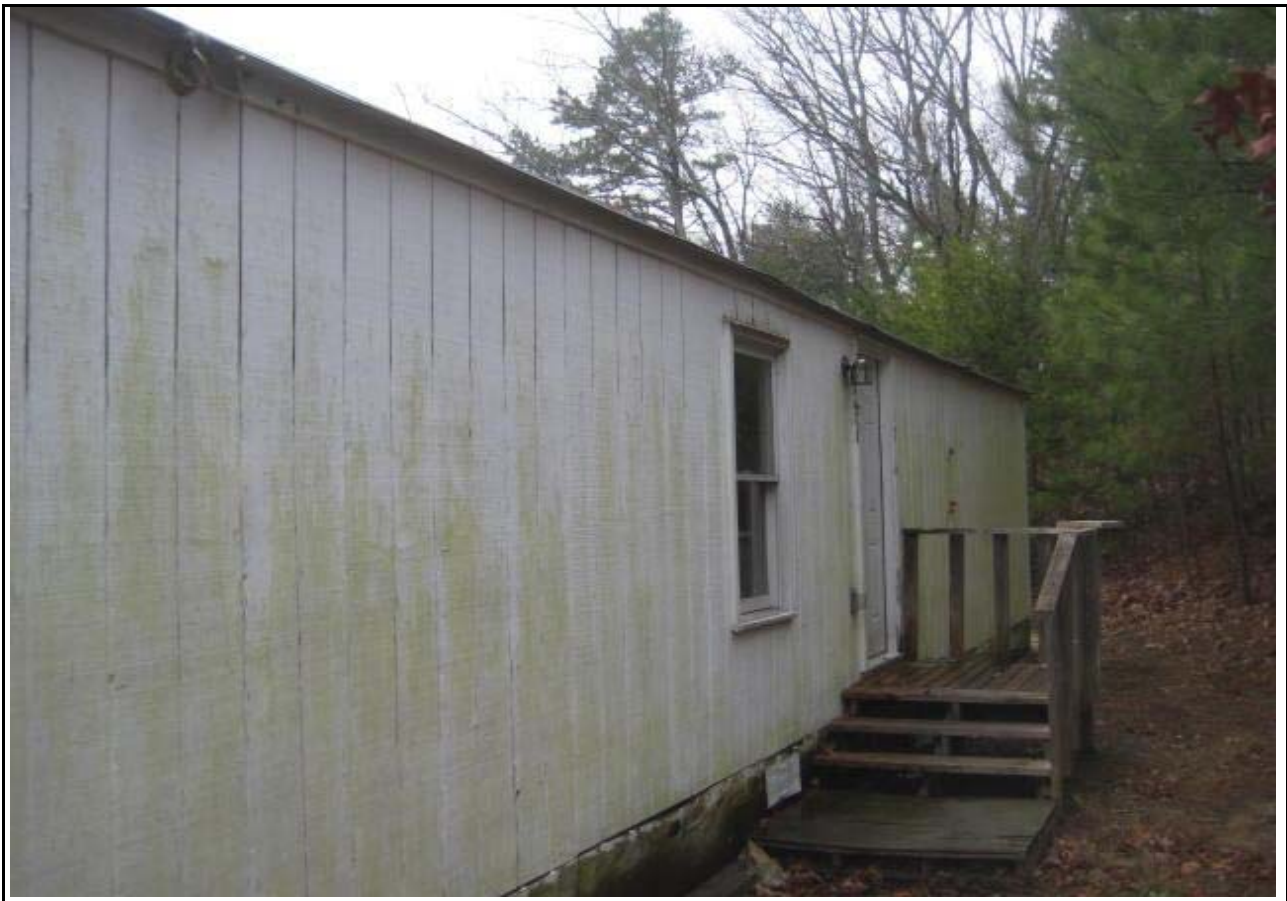
Photo-Rear View of Property

>Rear exterior door casing shows signs of moisture damage. Siding paint cracked and peeling throughout, Siding stained in rear of residence.
