Property Condition Report

Case #: 105-287045
Address: 112 Cypress Ct
City: Canton
State/Zip: GA 30115
Inspection Date: 5/5/09
Inspection Type: Property Condition Report (PCR)
Prepared by: DEANCO Management Services, Inc.

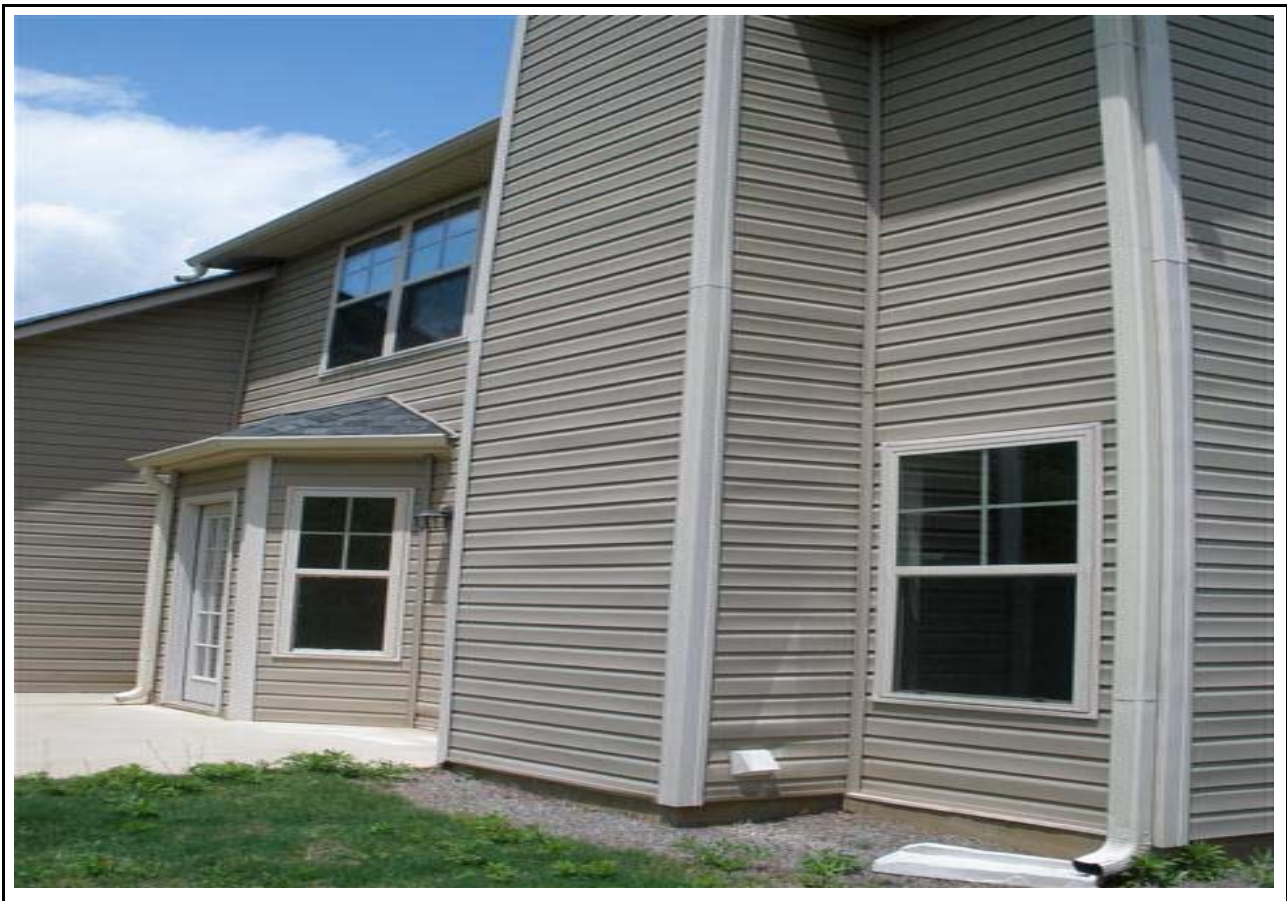
Photo-Rear View of Property

- > Siding at rear of residence is warped in an area
- > The trim around some of the windows is deteriorating
