Property Condition Report

Case #: 105-209339
Address: 1359 OLD MILL ROAD
City: BALL GROUND
State/Zip: GA 30107
Inspection Date: 10/3/08
Inspection Type: Property Condition Report (PCR)
Prepared by: DEANCO Management Services, Inc.

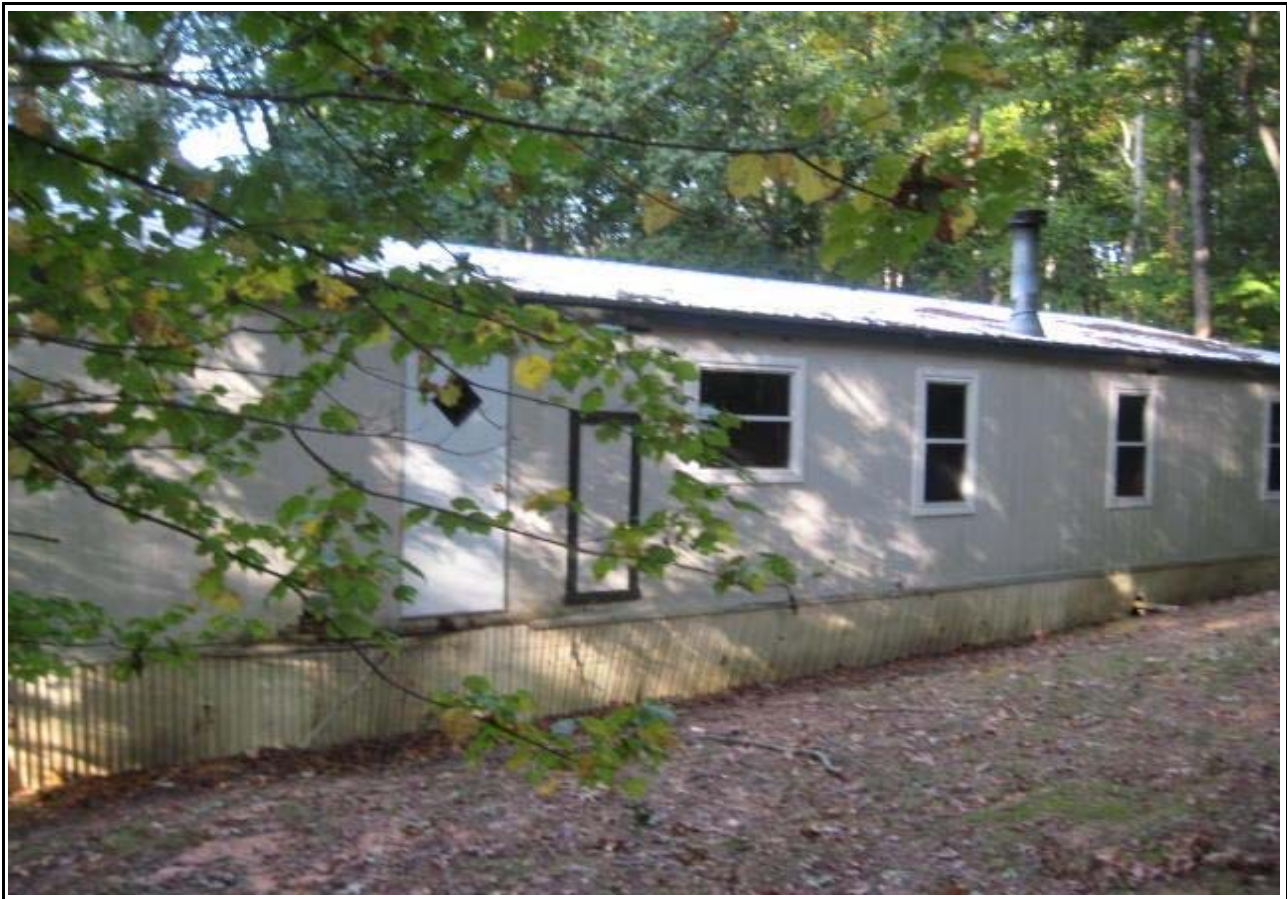
Photo-Rear View of Property

>Siding shows signs of moisture damage in rear of residence.

>Front storm door damaged. Rear door steps and railing missing.
